FULL COMMERCIAL INSPECTION REPORT

CONCEPT ONE, LLC

Inspection Date/Time: JANUARY 21, 2019 @ 1:00 PM

Property is: COMMERCIAL BUILDING

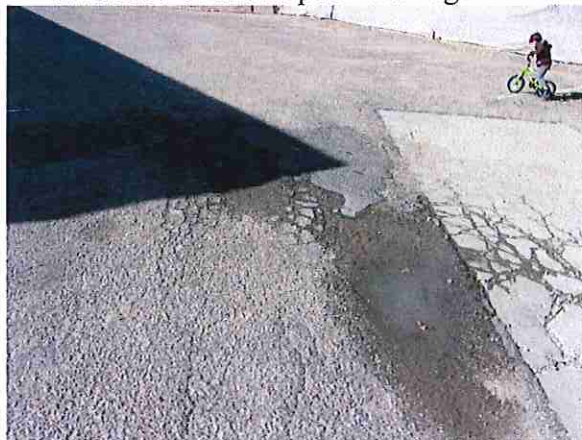
- Not fully visible
- Evidence of active poor drainage

- ~Potholes at various locations – possible trip hazards
- ~Surface raised/settled at various locations – possible trip hazards

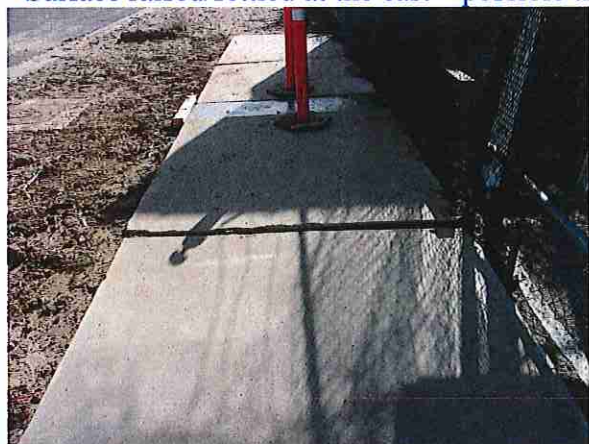
- ~Surface raised/settled at the east – possible trip hazards

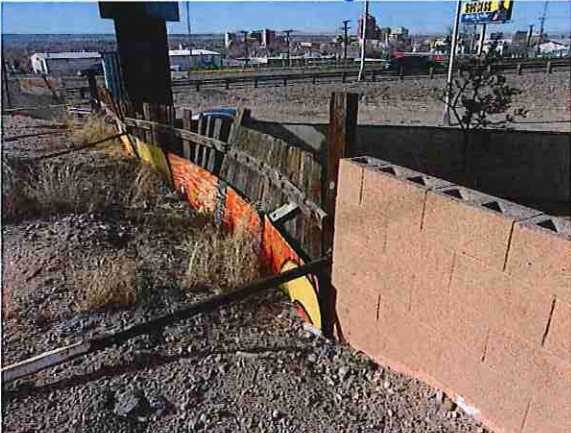
~Moderate-to-severe damage and displacement at the southwest wood retainer

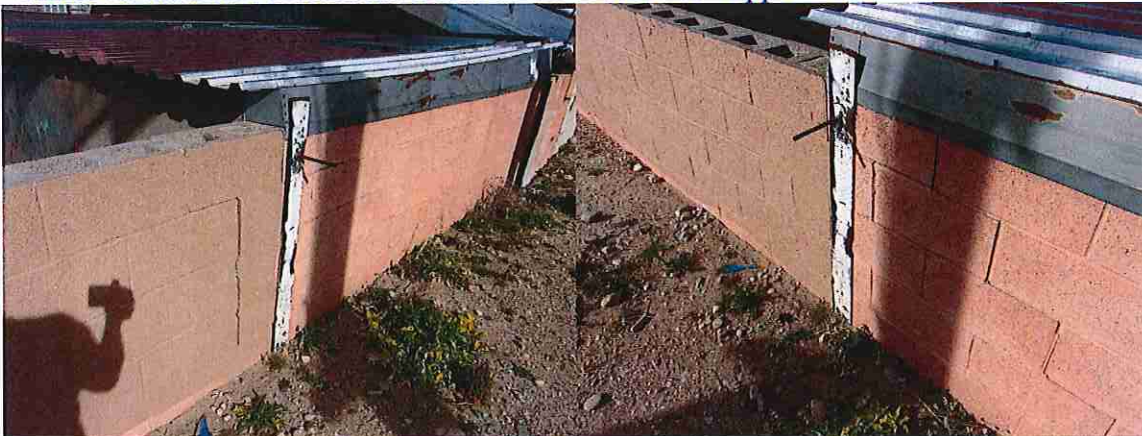
~Minor-to-moderate settlement cracks at the southwest – appears stable at the time of the inspection

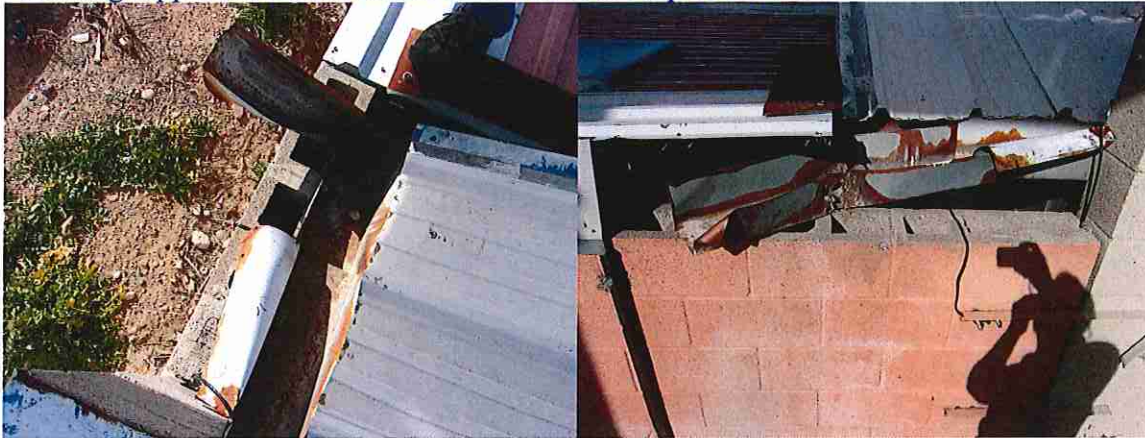
~Missing topper blocks at various locations at the top of the wall

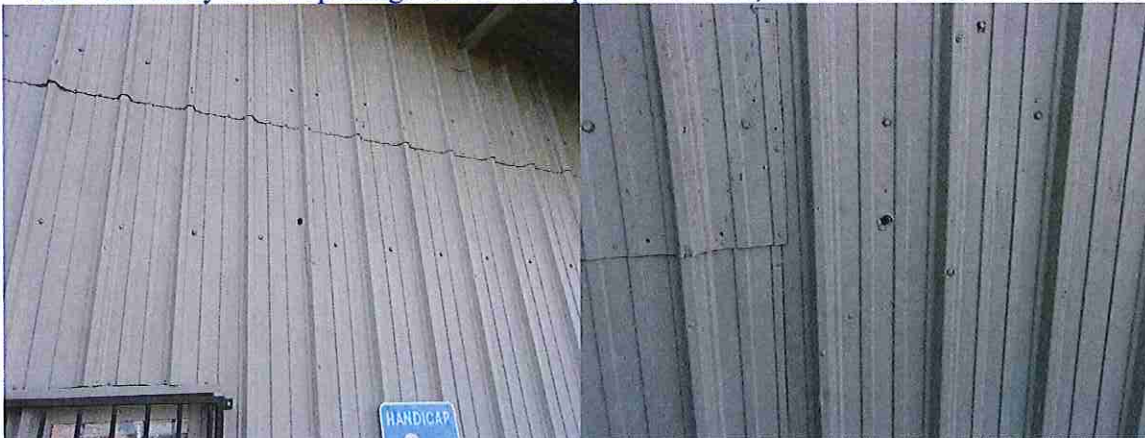
~There are many holes/openings that need repair at the east, north and south at various locations

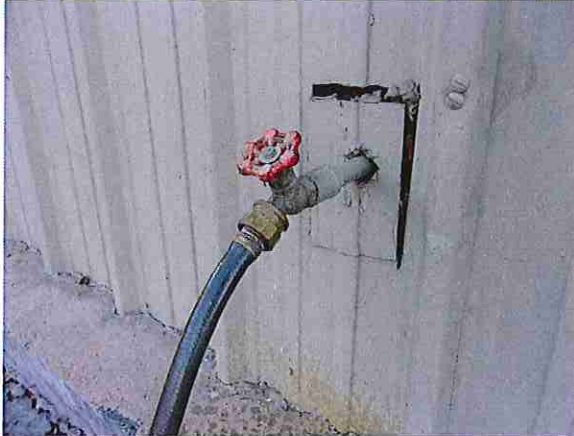
~Leaks at the east exterior wall valve stem – faucet and pipe are loose at the wall

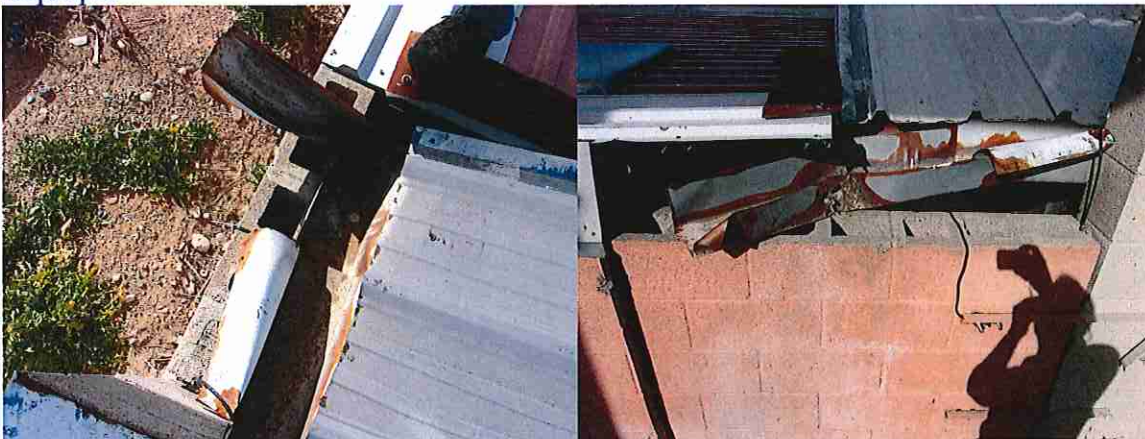
~Missing downspouts throughout

~Damaged, deteriorated and bent/alterd and routed into the neighboring property at the south – improper

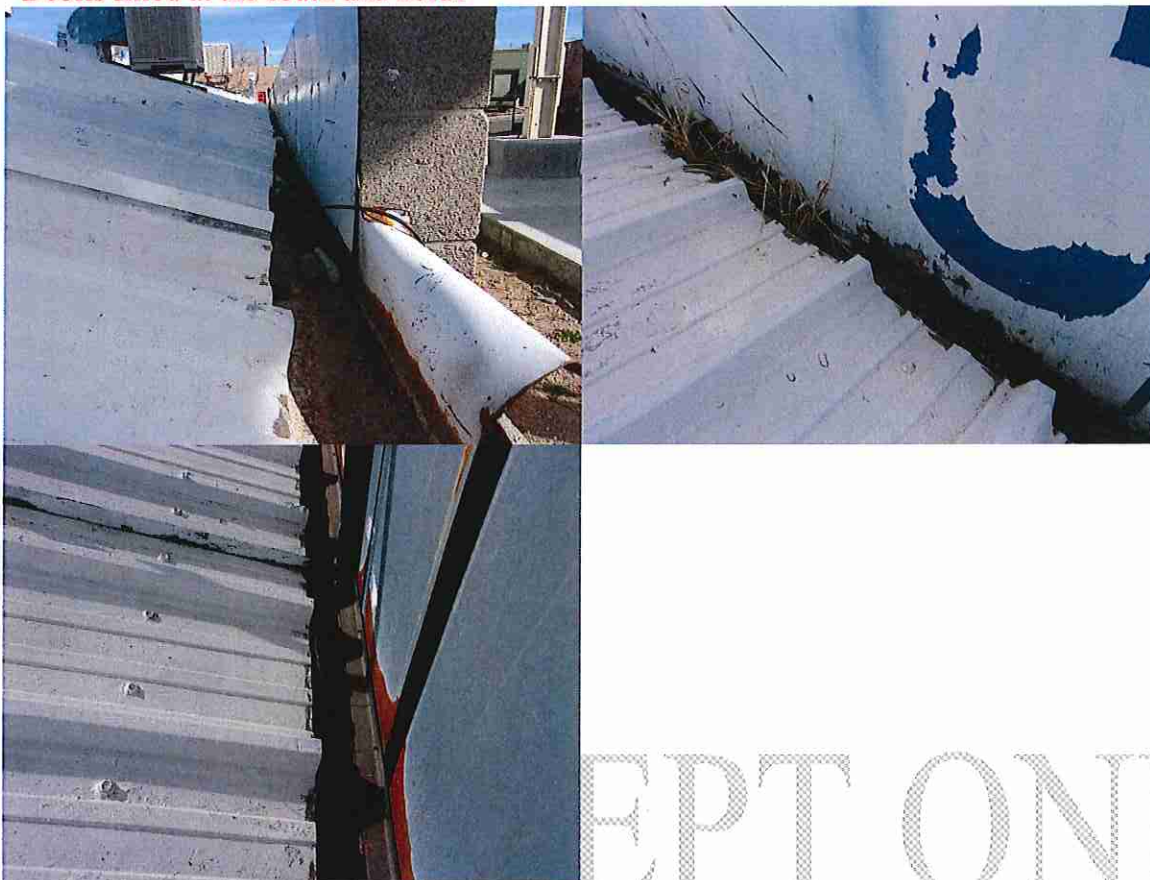
*Debris filled at the south and north

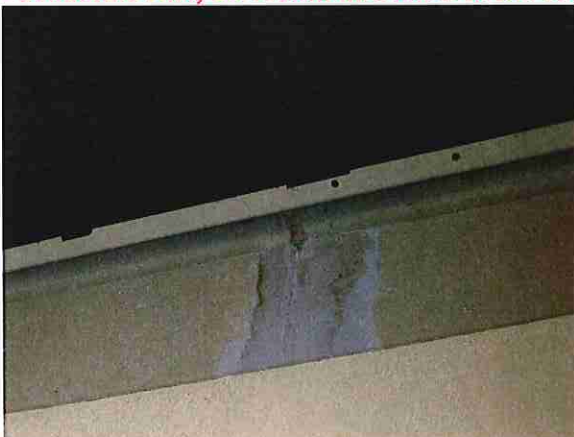
*Moderate rust, corrosion and leaks at the south – near the end of lifespan

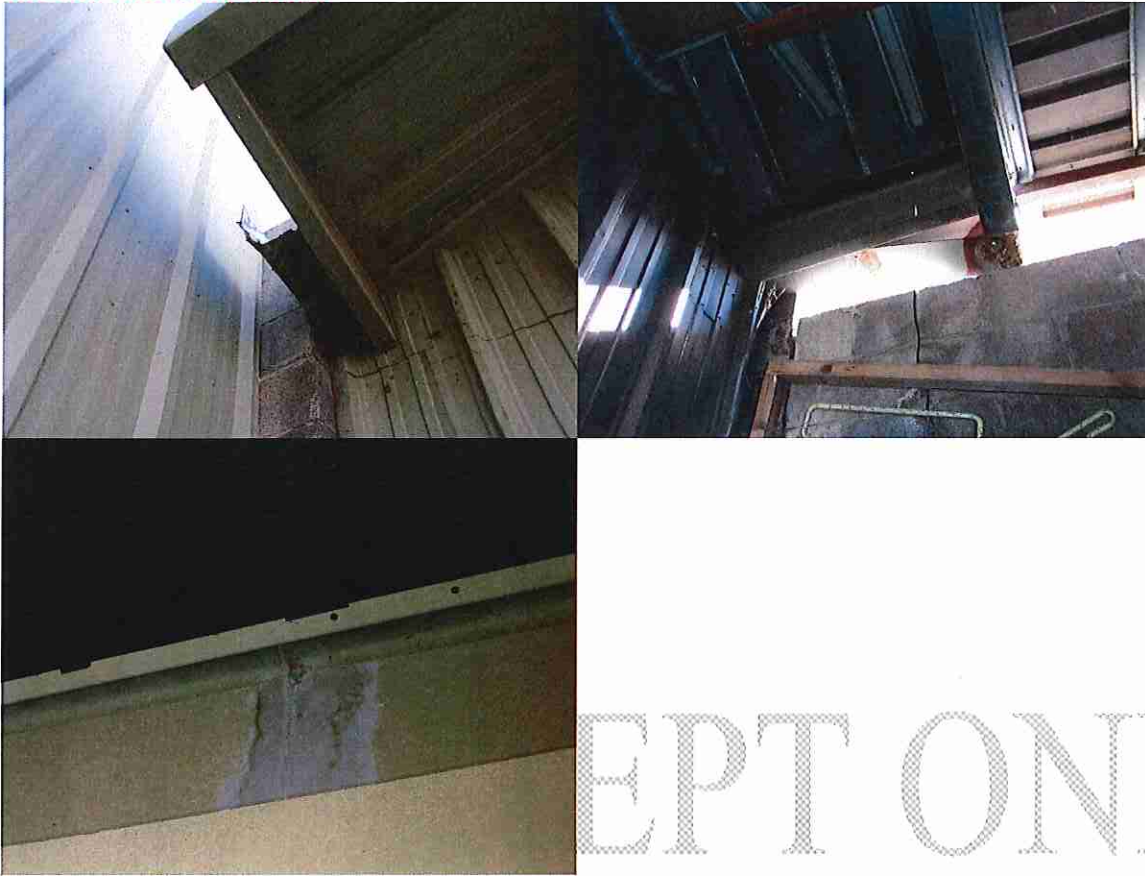
*Gutter is partially visible at the interior side of the sanctuary at the south wall/ceiling – evidence of leaks at various locations

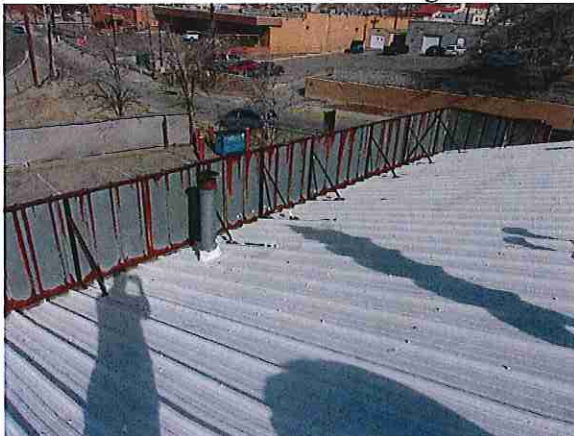
- General condition appears serviceable with signs of weathering and aging – regular inspections and maintenance advised.
- Evidence of moderate patching/repair at various locations throughout
- Minor-to-moderate rust throughout at the metal siding façade at the north

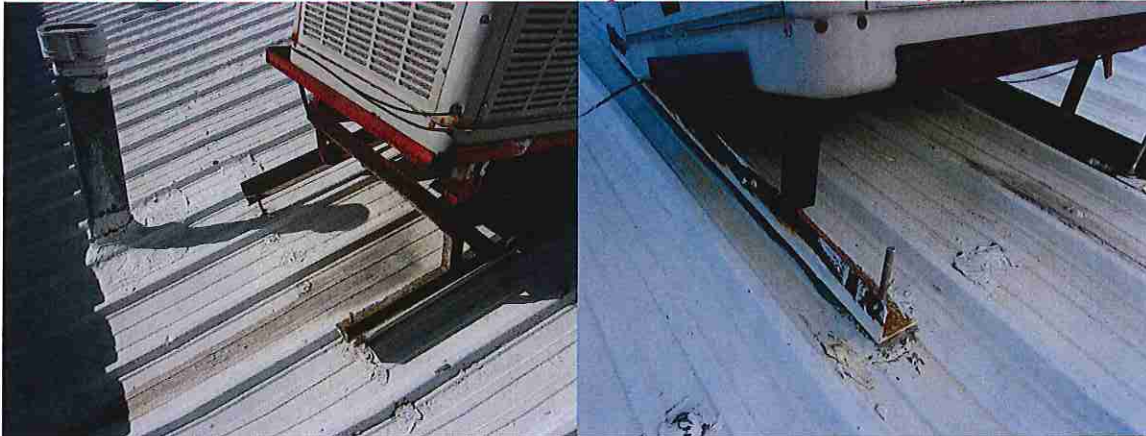
*Minor rust, corrosion and stains below the evaporative cooler units – dry at the time of the inspection

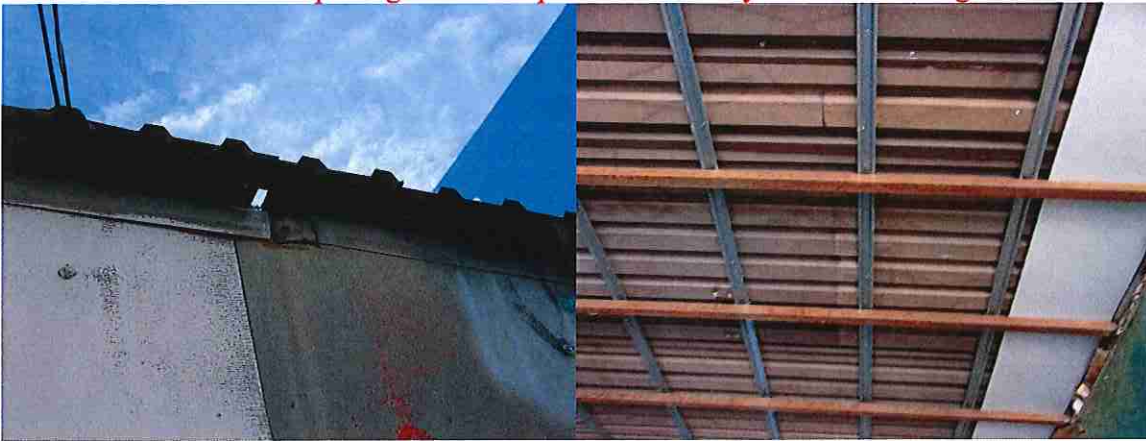
*There are small holes/openings at the carport roof at many locations throughout

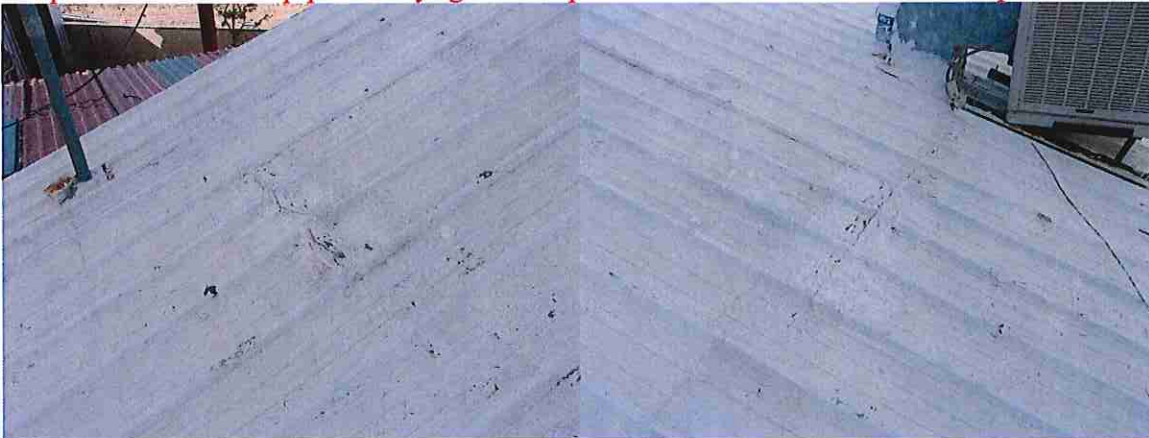
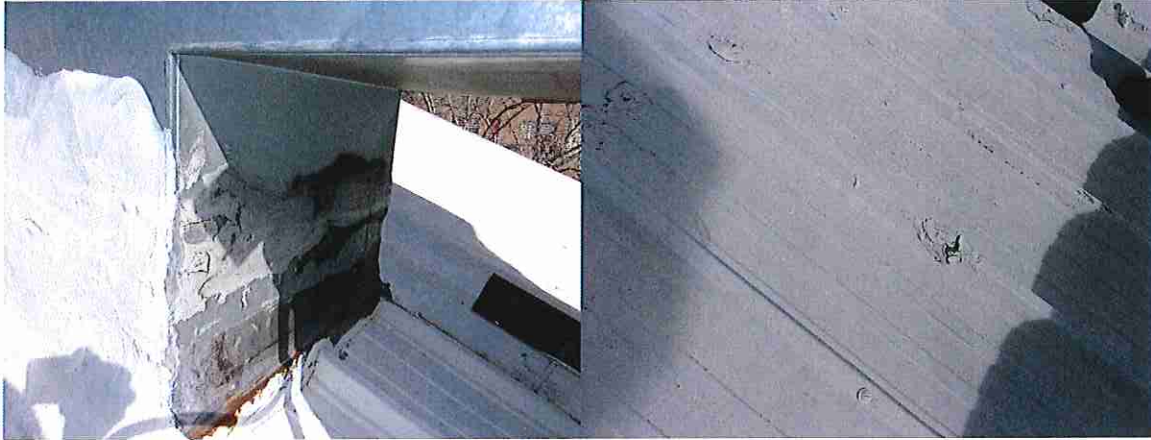
*Separations at: Vent pipes – Skylights – Exposed screws – Roof seams – Evaporative Plenum Seams

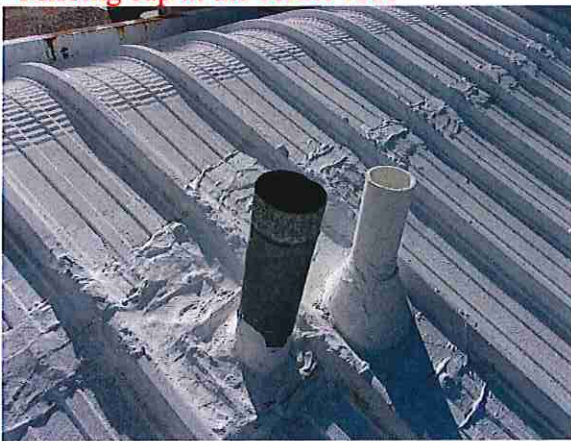
*Missing cap at the center roof

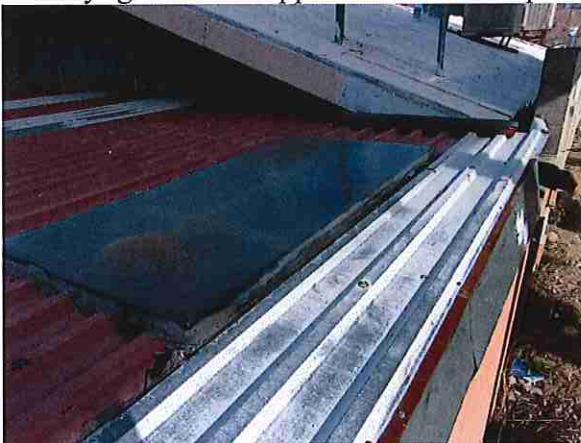
- Skylights do not appear to have been professionally installed throughout

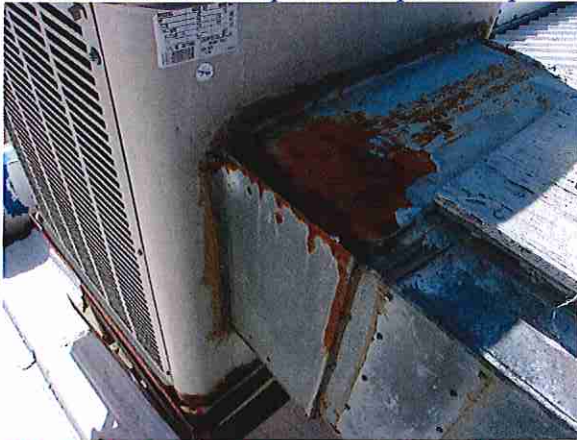
~Minor rust at the exposed evaporative plenum at both units

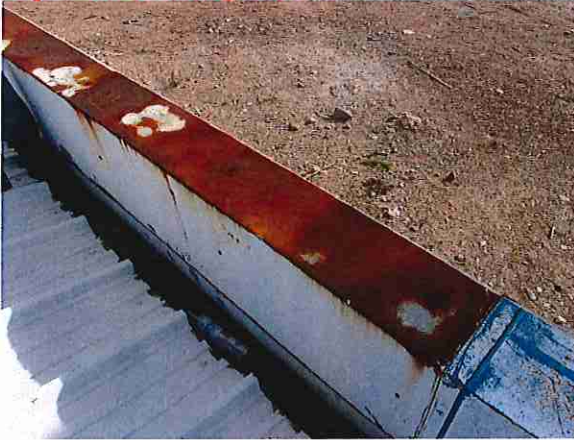
*Rusty flashings at the parapet/top retainer wall at the south with seam separations and exposed/extruding screws

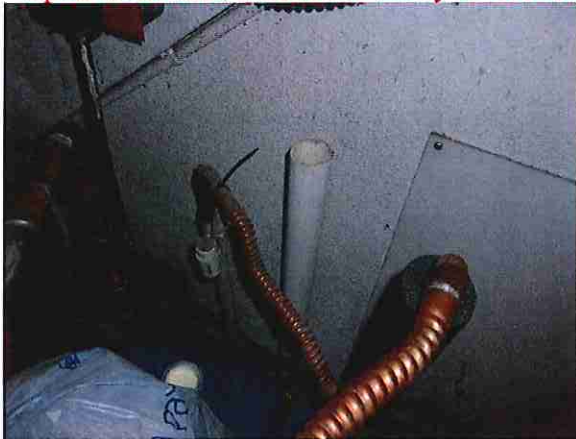
***Open waste line/vent at the utility closet at the east wall**

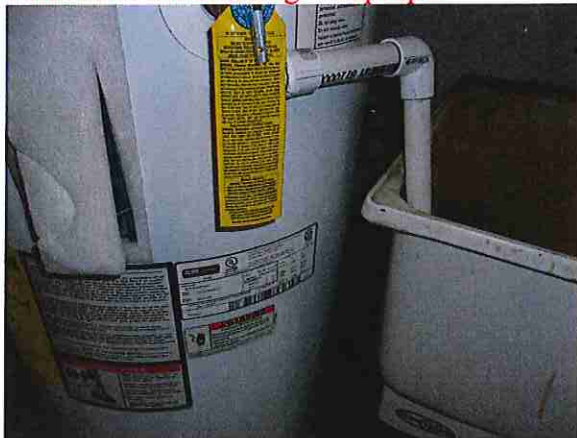
*The TPR overflow pipe has unsafe termination in to the utility sink – not routed to a drain or to the exterior of the building – improper

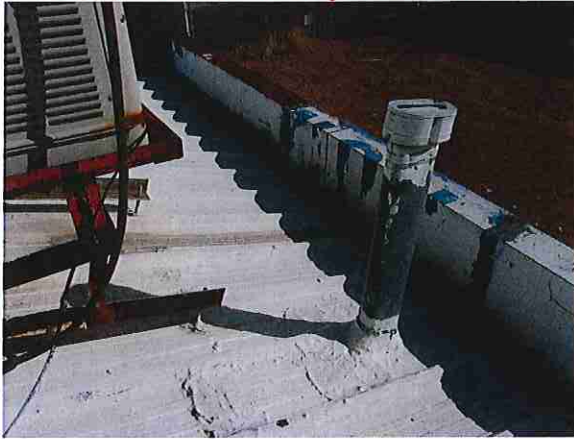
*Rust on the vent pipe and cap for the Modine unit at the roof

*The roof vent for the Dayton unit needs to be extended to rise at least 2' above the evaporative cooler

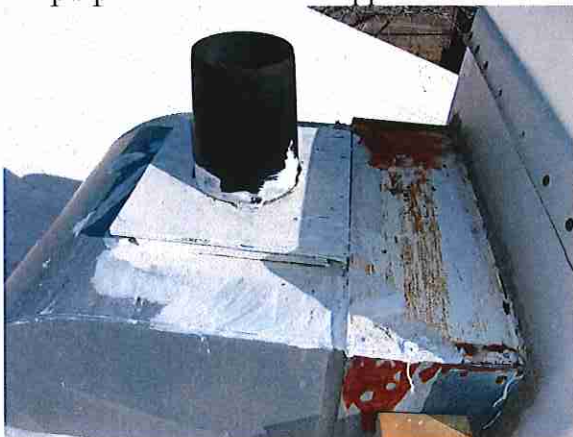
- Black bucket/funnel and plywood added at the exposed east roof evaporative cooler plenum – purpose is unknown – appears abandoned/not in use – recommend removal

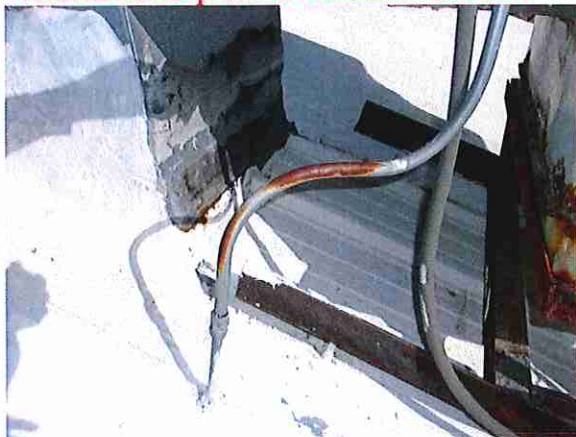
*Unit is winterized with parts in place – unable to test

*Rusted and separated conduit at the unit

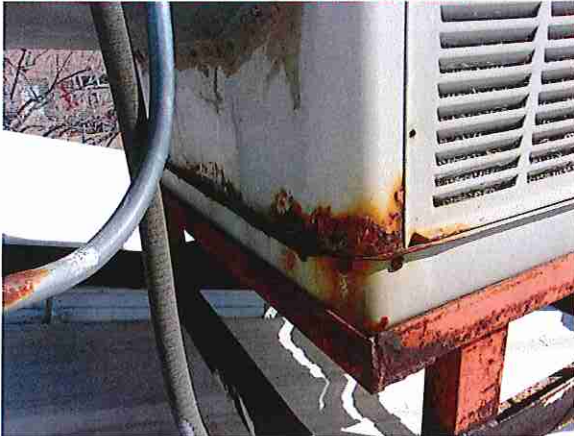
*Moderate-to-severe rust on the unit

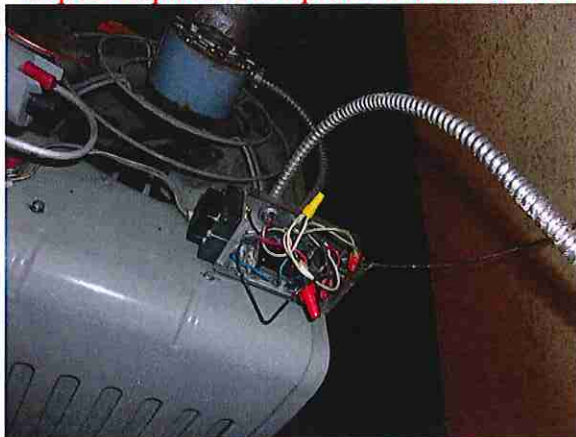
*Exposed splices need protection at the back side of the Modine furnace

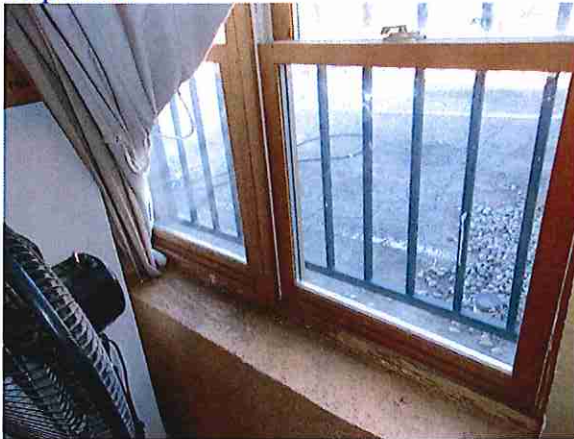
~Minor-to-moderate moisture stains and damage at the east office (2 of 2) – dry at the time of the inspection

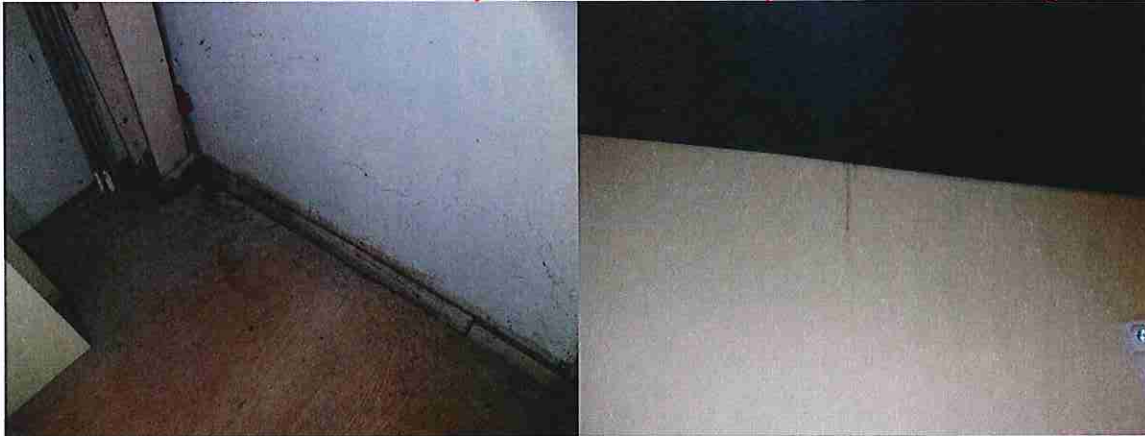
*Minor-to-moderate moisture stains at the bottom of the west wall and base trim at the southwest mechanical closet and at the sanctuary at the south wall – dry at the time of the inspection

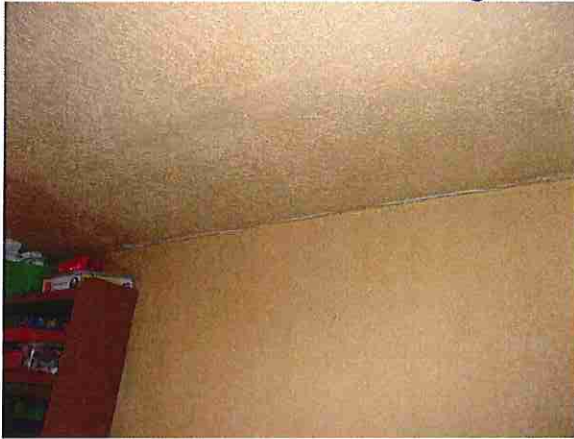
~Minor settlement cracks at the lounge at the south wall to ceiling seam

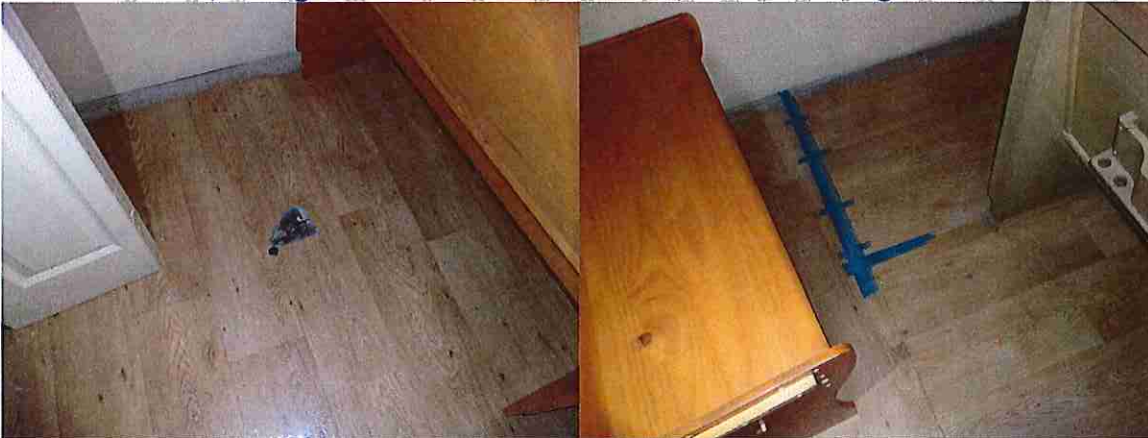
~Moderate wear, damage and deterioration at various locations throughout

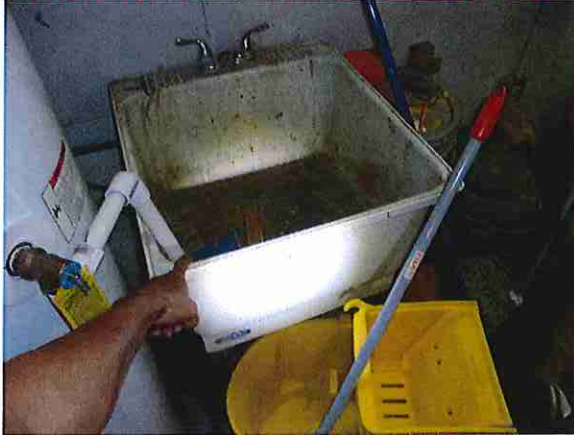
***The utility sink is loose/not secured to the wall/floor – improper**

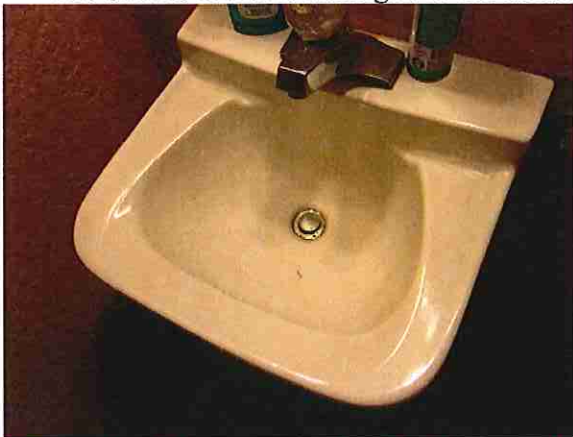
- The sink is cracked/damaged at the men's restroom
