FULL HOME INSPECTION REPORT

CONCEPT ONE, LLC

Inspection Date/Time: MARCH 7, 2019 @ 1:15 PM

Property is: SINGLE FAMILY HOUSE

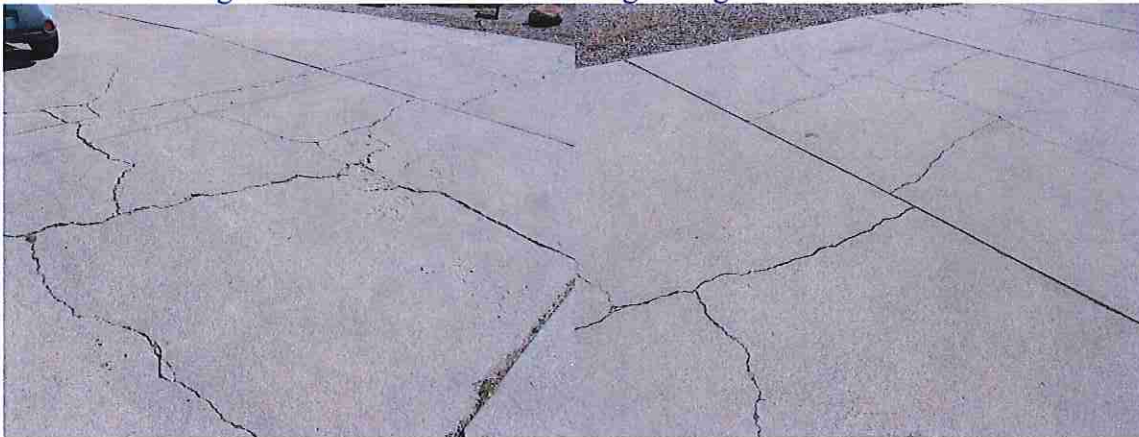
~Moderate to large settlement cracks need sealing throughout

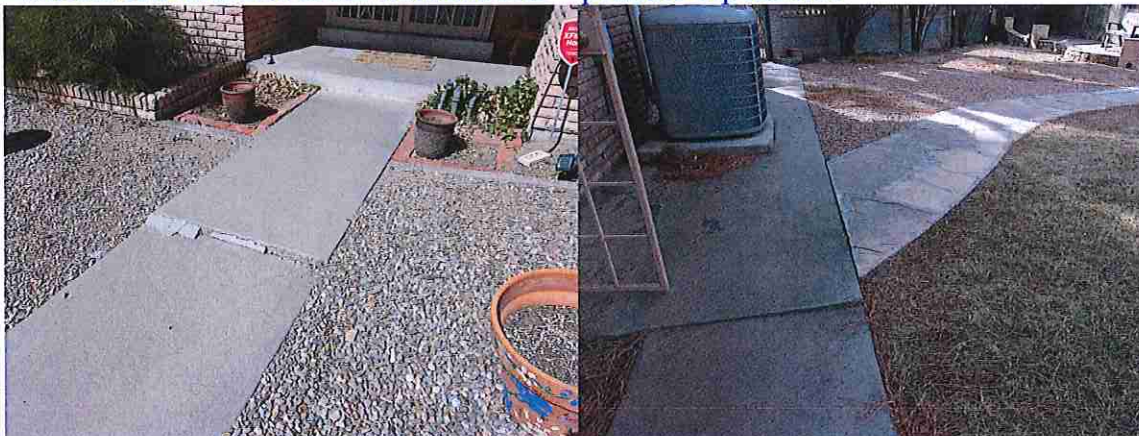
SIDEWALKS/WALKWAYS

~Settlement cracks of 1/8" or larger need sealant at a few locations

~Surface raised/settled at the front and rear – possible trip hazards

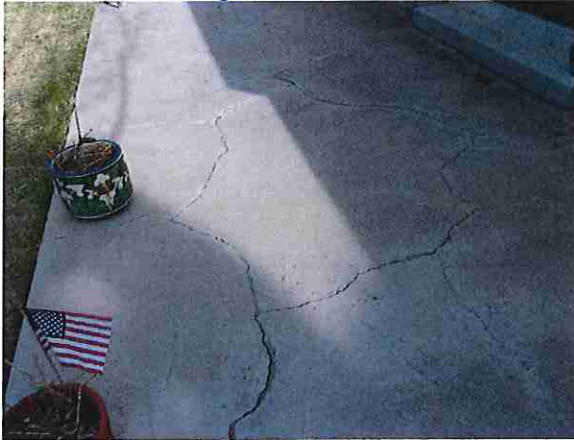
~Moderate to large settlement cracks need sealing throughout

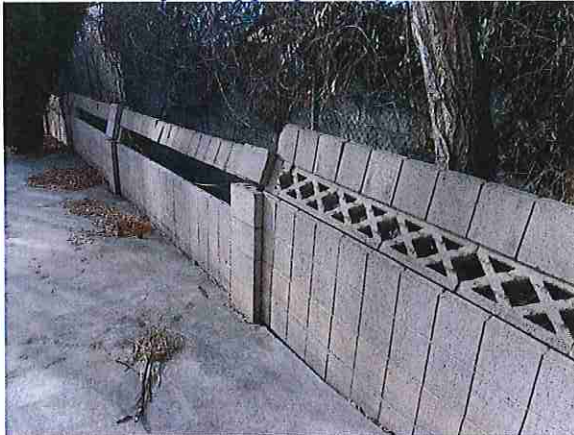
~There are many loose and/or missing blocks at the rear at the north and northeast at various locations – moderate leaning – the wall does not appear stable at the time of the inspection – recommend further evaluation by an appropriately licensed contractor

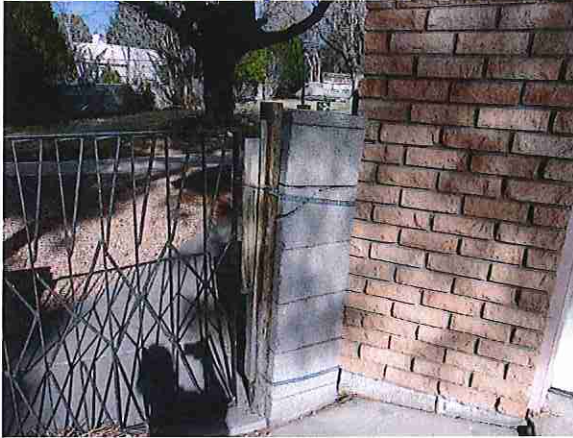
~The gate at the west is displaced/wired shut with loose/unstable block pilaster – does not appear stable at the time of the inspection – recommend further evaluation by an appropriately licensed contractor

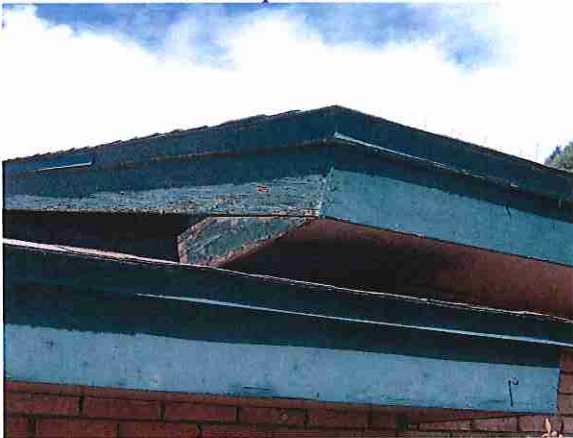
~Minor to moderate moisture stains and damage at the fascia sills at various locations throughout – dry at the time of the inspection

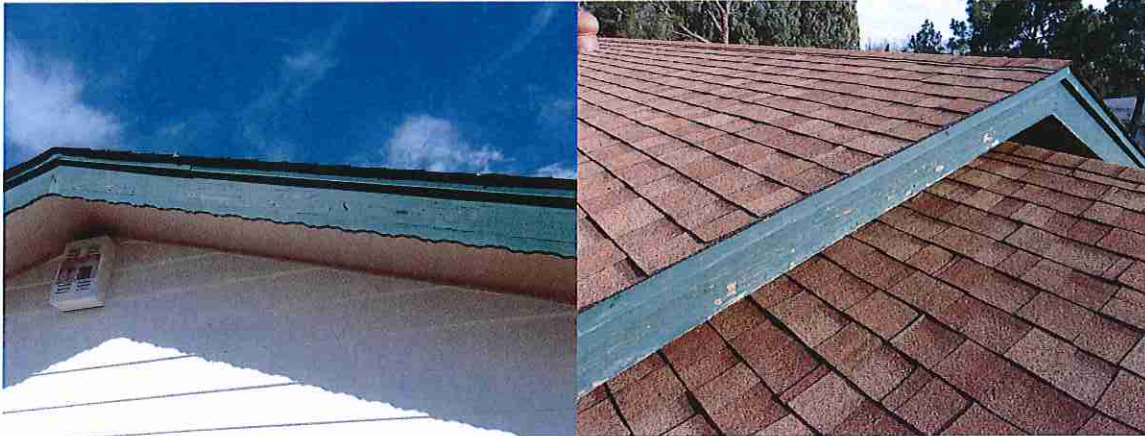
~Paint is deteriorated at the wood trim and fascia at various locations throughout

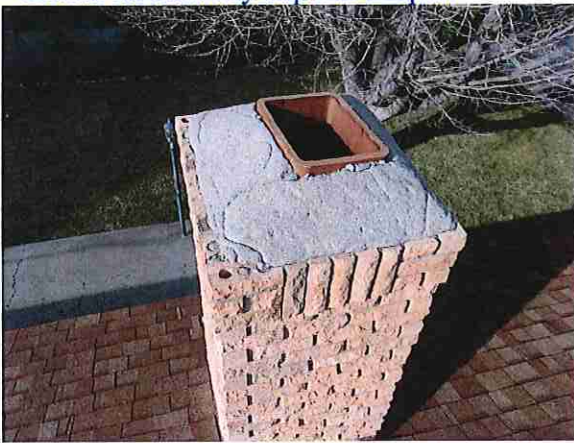
CHIMNEY

~Cracks in chimney cap need repair

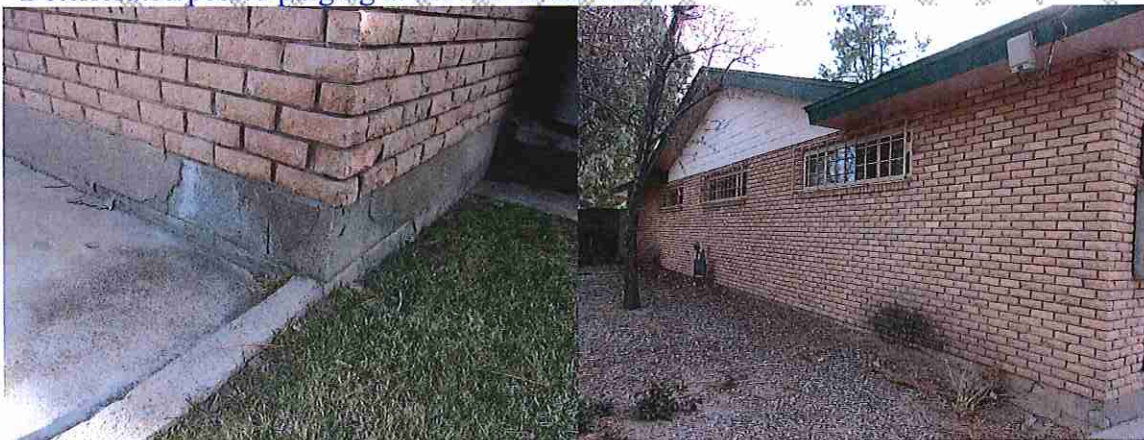
~Deteriorated/peeled parging at the rear at the north

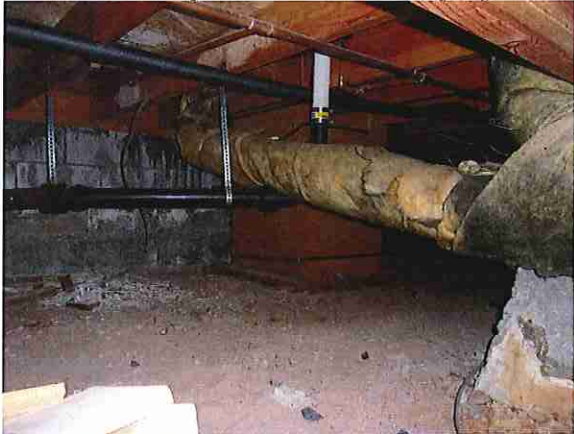
- There was debris under the house at the time of the inspection
- There is a plywood box at the southeast – earth to wood contact – the inspector was not able to get close enough to determine the purpose of the box – recommend further evaluation

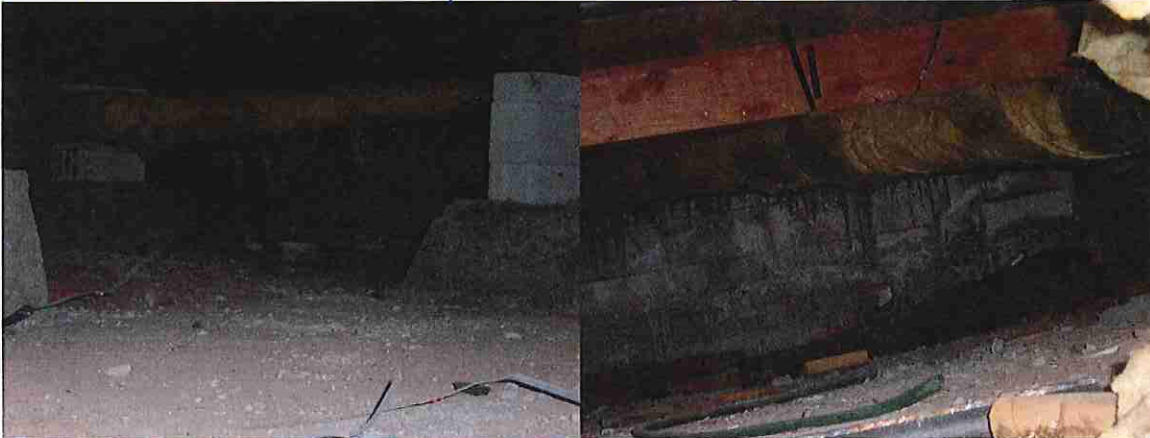
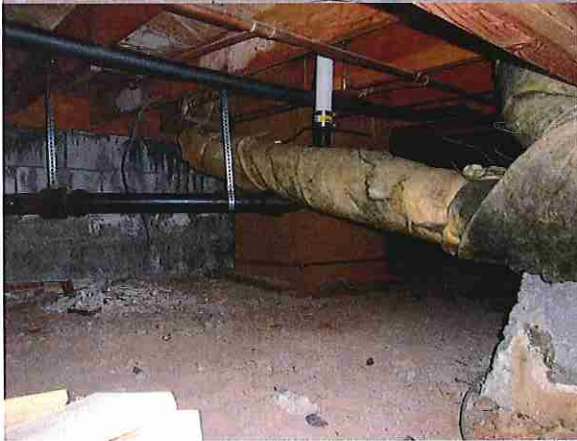
~Evidence of moisture penetration (efflorescence) at the foundation walls throughout with minor to moderate surface deterioration – dry at the time of the inspection

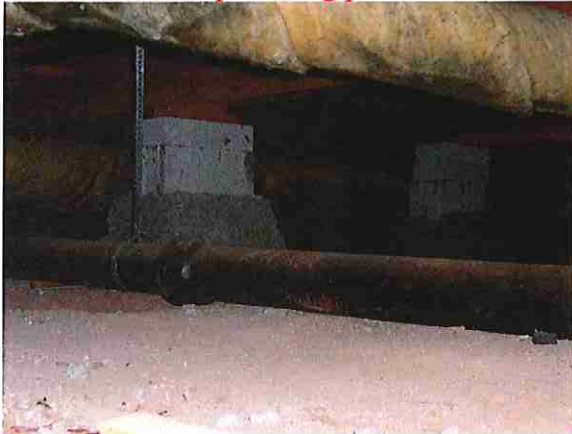
*Duct work and plumbing prevented full access – not fully inspected

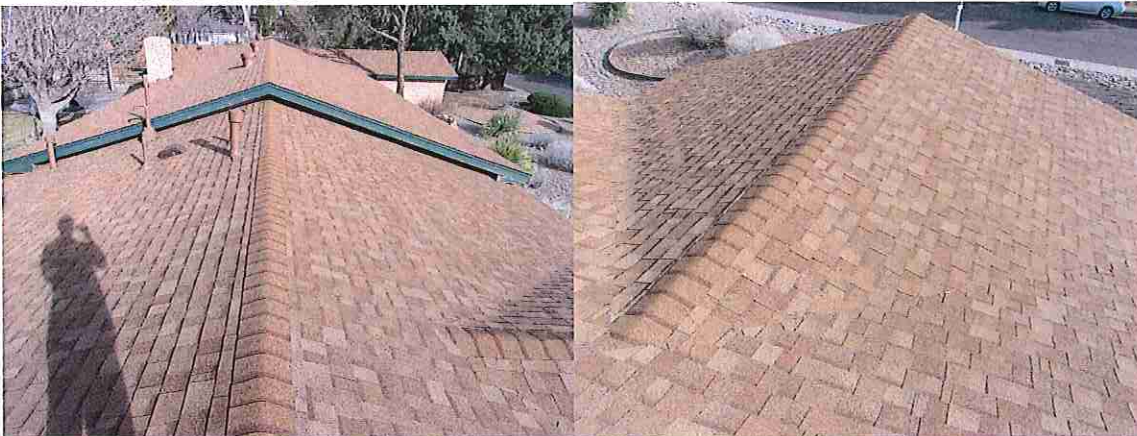
- General condition appears serviceable with signs of weathering and aging – regular inspections and maintenance advised.

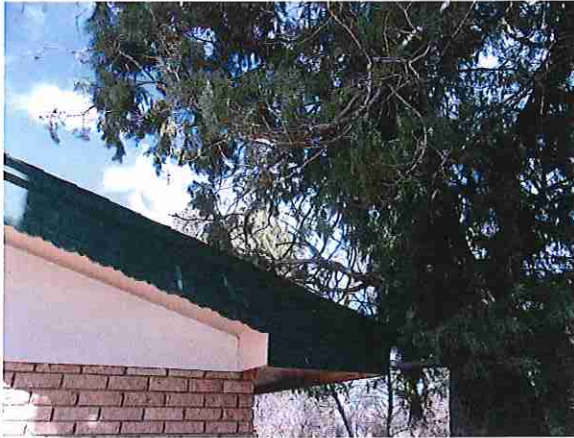
*Tree touches the roof at the southeast

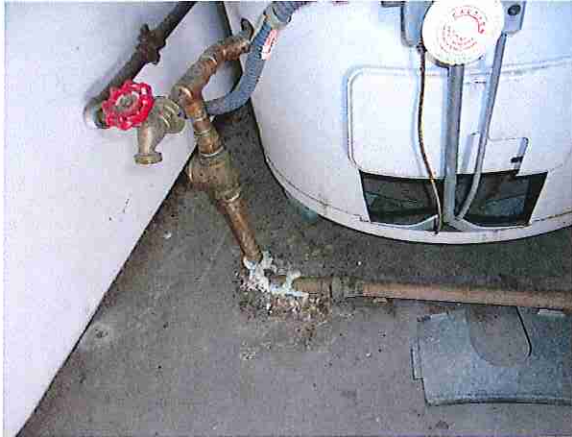
*Severe rust/corrosion at the garage near the water heater – pipe touches the ground

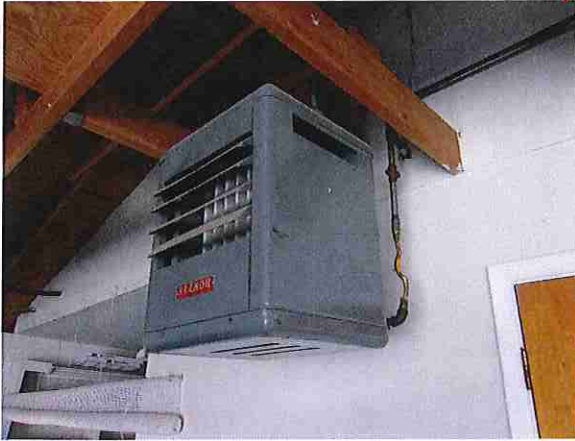
FURNACE NOTES

- The Carrier Furnaces are HVAC combination units
- *The Reznor unit is not warrantable due to type/location*

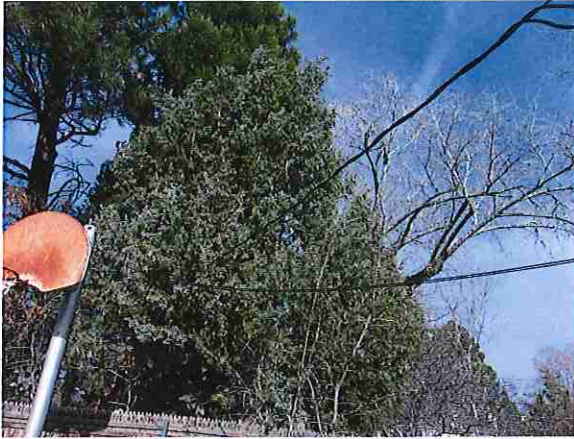
- Wires touch trees – contact utility company

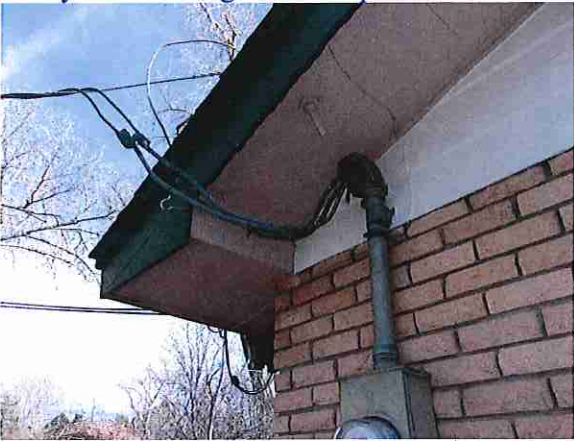
- The electrical masthead is located below the roof overhang - improper
~Frayed sheathing on the exposed service wires

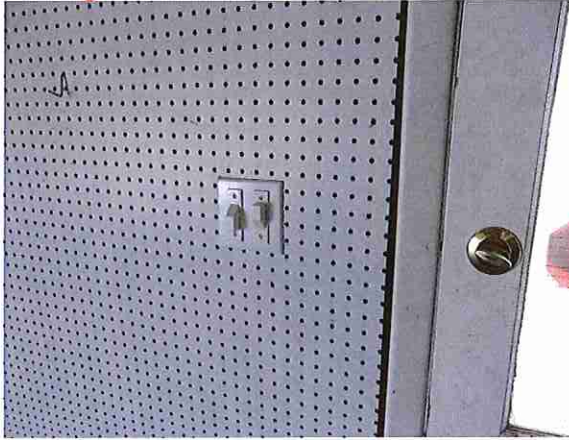
*Loose outlet at the kitchen at the south (1 of 3)

*Missing cover plates at the garage open frame ceiling at a few locations

*The living room outlet at the north (1 of 2) has been painted over – not tested

*Garage switches at the north wall were blocked with covers/not tested

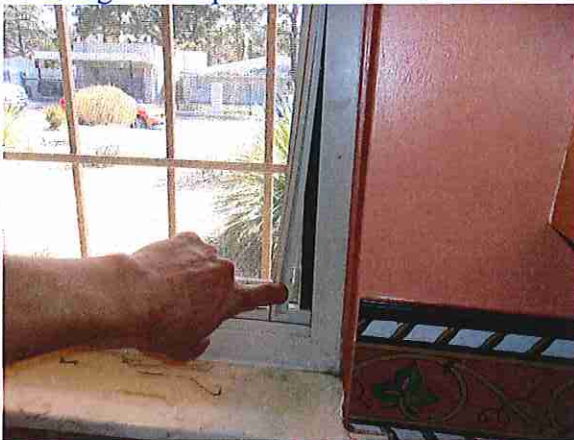
- ~Security bars are difficult to release at various bedrooms
- ~Security bars are not designed to open at bedroom 6 – fire egress hazard**
- ~Damage at the pull handle at the kitchen

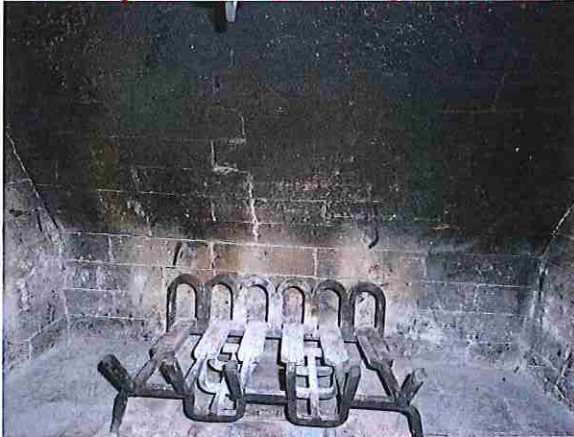
- Flue: Recommend cleaning before use
- Damper: Operational
- There are a few cracked bricks in the fire box that need sealing

***The fireplace is wood burning – not tested – not warranted by Concept One, standard exclusion.**

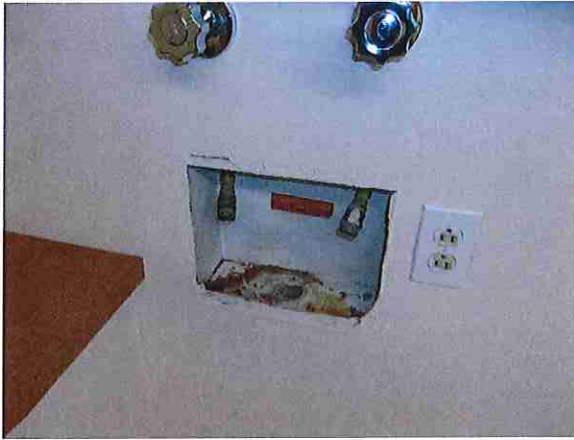
~No room ventilation provided – recommend installing an exhaust fan

***Moderate rust and corrosion at the washer box**

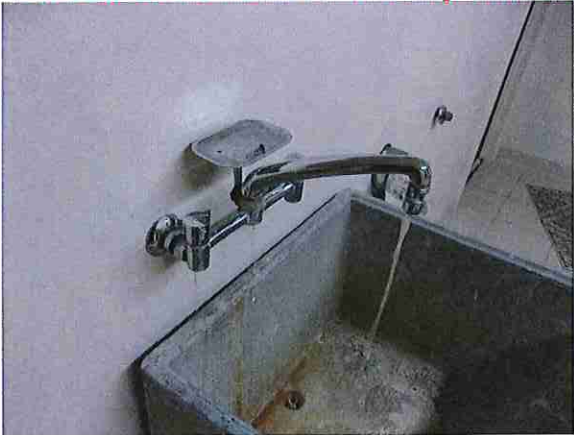
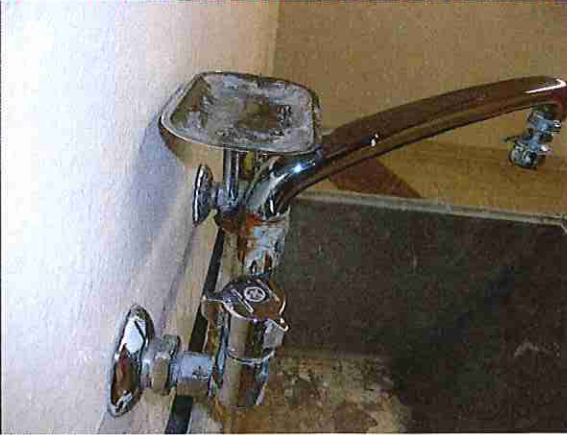
- The dryer vents into a lint catching sock at the garage east wall – improper
- There is a floor drain installed – not tested – not inspected

***Sink not secured to wall/floor**

***The sink faucet has a constant drip with severe corrosion/deterioration at the neck swivel**

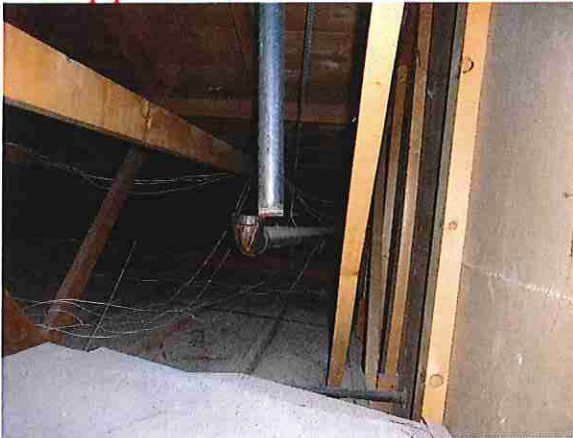
- Small stains
- Insulation is compressed and appears minimal

*Vent pipe is not connected at the west near the access

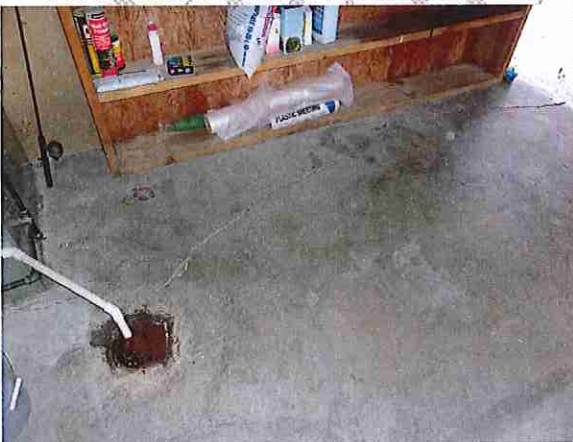
- Not fully visible
- Floor surface drain at the northeast – not tested

~There is a crack of 1/4" or larger that runs across the floor at the northeast – needs sealant/repair

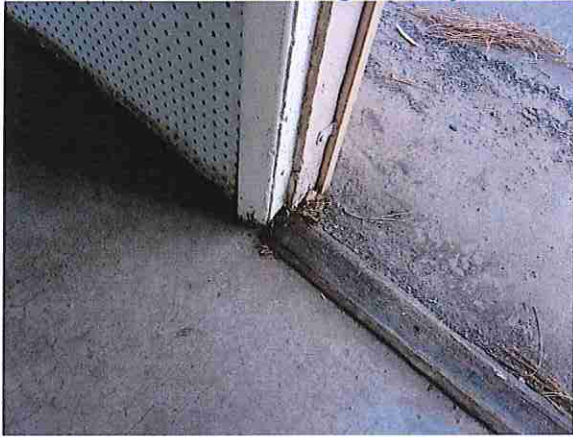
~Moderate moisture damage at the jamb and threshold – dry at the time of the inspection

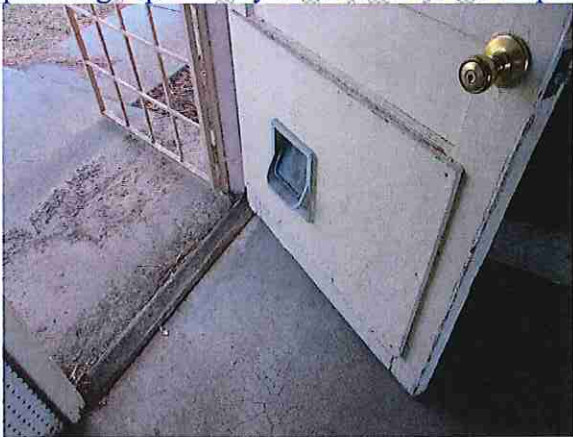
~There is minor to moderate moisture damage at the bottom half of the door with evidence of prior patching/repair – dry at the time of the inspection

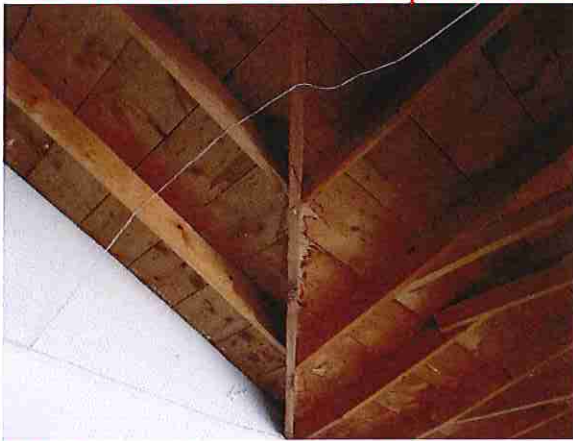
- A few stored items block view of entire garage – unable to fully inspect
- *Minor moisture stains on the open frame ceiling at the southeast – dry at the time of the inspection

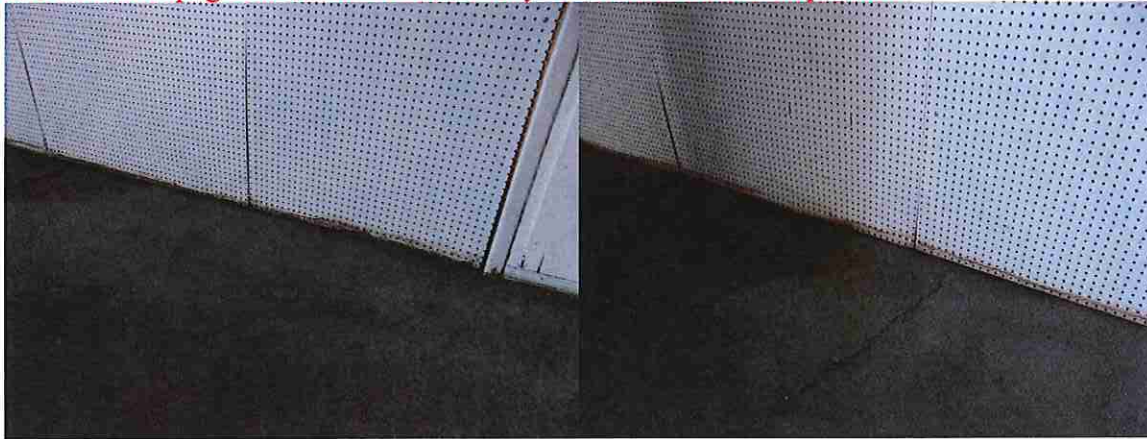
- *Moderate moisture stains and damage at the base of the north wall peg board throughout – the sill plate is behind the peg board – not visible – dry at the time of the inspection

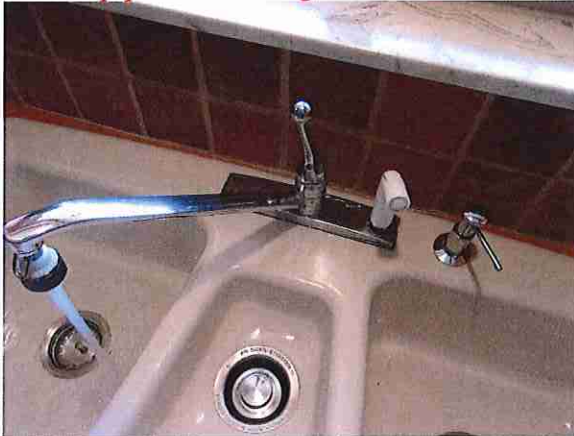
- Restricted view below the sink
- Moisture stains/damage below the sink – dry at the time of the inspection

*Faucet leaks at the neck swivel when in use

***Drain pipes are leaking at various locations**

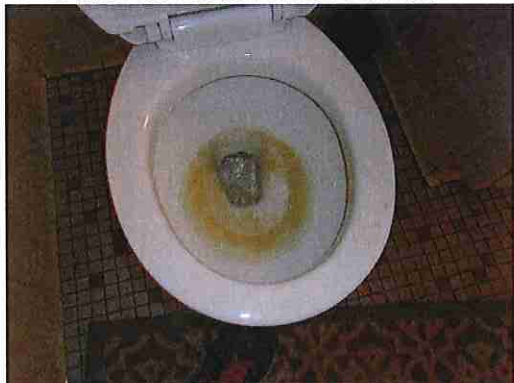
- Toilet bowls are water stained
