FULL COMMERCIAL INSPECTION REPORT

CONCEPT ONE, LLC

Inspection Date/Time: JANUARY 21, 2019 @ 1:00 PM

Property is: COMMERCIAL BUILDING

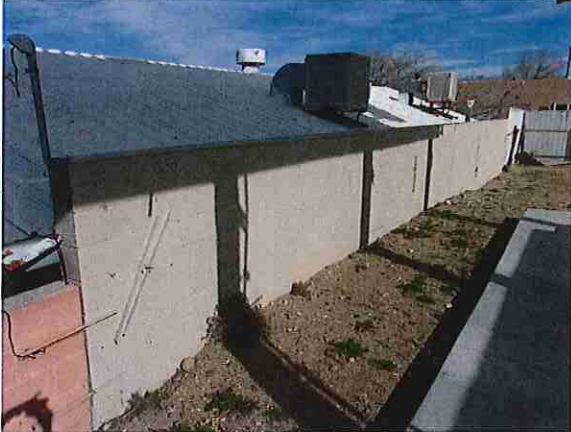
- ~Moderate-to-severe damage and displacement at the southwest wood retainer
- ~Minor-to-moderate settlement cracks at the southwest – appears stable at the time of the inspection
- ~Missing topper blocks at various locations at the top of the wall

~Moderate-to-severe damage and displacement at the southwest wood retainer

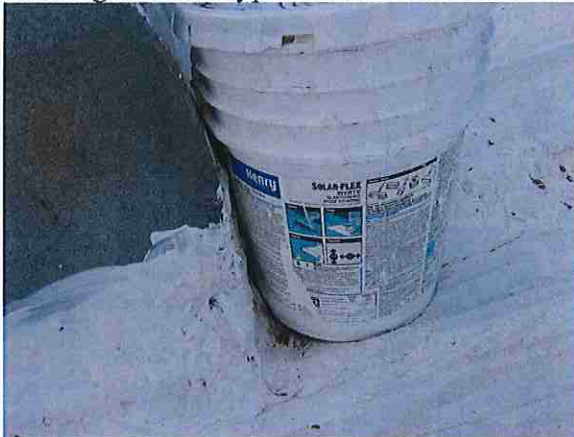
- General condition appears serviceable with signs of weathering and aging – regular inspections and maintenance advised.
- Evidence of moderate patching/repair at various locations throughout
- Minor-to-moderate rust throughout at the metal siding façade at the north
